# Remediation Strategies and Water Quality of Estuarine Impoundments

Jens Lamping

A thesis submitted in partial fulfilment of the requirements of the Council of the University  
of Durham for the Degree of Doctor of Philosophy (PhD)

### **Remediation Strategies and Water Quality of Estuarine Impoundments**

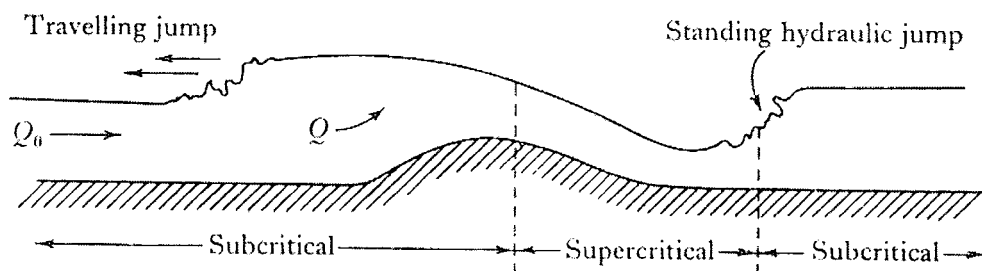
**Figure 3-4 Travelling and standing hydraulic jumps associated with flow constriction (Turner, 1973)**

Similar to surface jumps (i.e. surges, bores) internal jumps are created as a result of the different Froude numbers. If the flow increases from sub-critical to super-critical around an obstacle an upstream travelling jump can be created while the backwards transition downstream can lead to a standing hydraulic jump. Baddour and Abbink (1983) and Baddour (1987) investigated the behaviour of a super-critical underflow discharge of

The restriction of flow leads to an increase in velocities which can result in the occurrence of localised super-critical and sub-critical conditions (Figure 3-4).

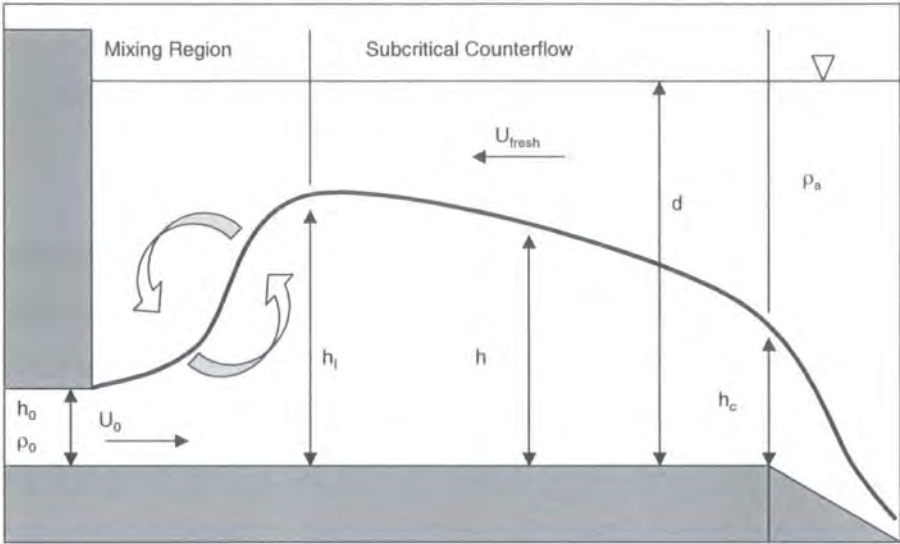
seawater into a confined channel of freshwater to determine maximum interfacial mixing conditions. Their experiments revealed the occurrence of a relatively short mixing zone featuring an internal hydraulic jump and a sub-critical counterflow region characterized by a stable interface (Figure 3-5).

Figure 3-5 Definition sketch of underflow discharge channel (after Badour, 1987)

For a higher amount of downstream control, i.e. a decrease in  $h_c$  (Figure 3-5), it is anticipated that the hydraulic jump will travel upstream, resulting in a drowned discharge exit (Figure 3-6 a)). This *drowned internal jump* reduced the amount of dilution significantly. When the discharge Froude numbers exceeded  $F_0 \cong 15$  through the variation of  $h_0$

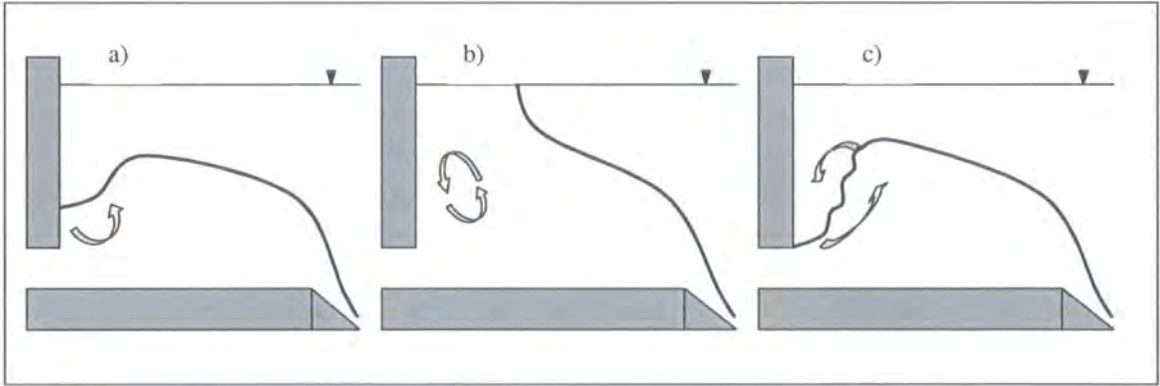
Figure 3-6 Mixing modes observed by Baddour (1987)

(upstream control), an *upstream control instability* developed, in which the internal jump reaches the surface boundary (Figure 3-6 b)). The same instability could be triggered by lowering the overall depth of the compartment, via downstream controls, so that the depth confinement would physically restrict the development of an internal or drowned jump referred to as *downstream control instability* (Figure 3-6 b)). The perfect balance between those interacting controls ensures the development of a *free internal jump* (Figure 3-6 c)), which provided maximum dilution rates of the water bodies through turbulent entrainment at the interface.

By varying the control parameters upstream ( $h_0$ ) and downstream ( $d$ ) of the mixing compartment, a total of three mixing modes (Figure 3-6) were observed which provided different dilution rates between the water bodies.

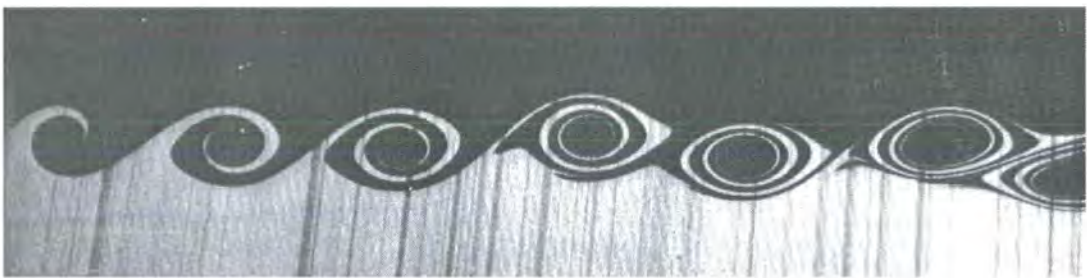
Since the Richardson number is a measure of interfacial stability, it can be used to evaluate the development of instabilities, such as Kelvin-Helmholtz billows (Figure 3-7). These large billows form at conditions of  $Ri < 0.25$  induced by velocity shear on the interface. They feature a vortex that eventually breaks down into a turbulent core, resulting in entrainment of the two involved layers. For  $Ri > 0.25$  smaller scale mixing processes, in which current shear is introduced to a stable interface, are represented by interfacial Holmboe waves (Figure 3-8). These cusp-like progressive waves break down and eject elements from a denser layer into the lighter layer causing entrainment.

Figure 3-7 K-H-Billows (from Van Dyke, 1982)

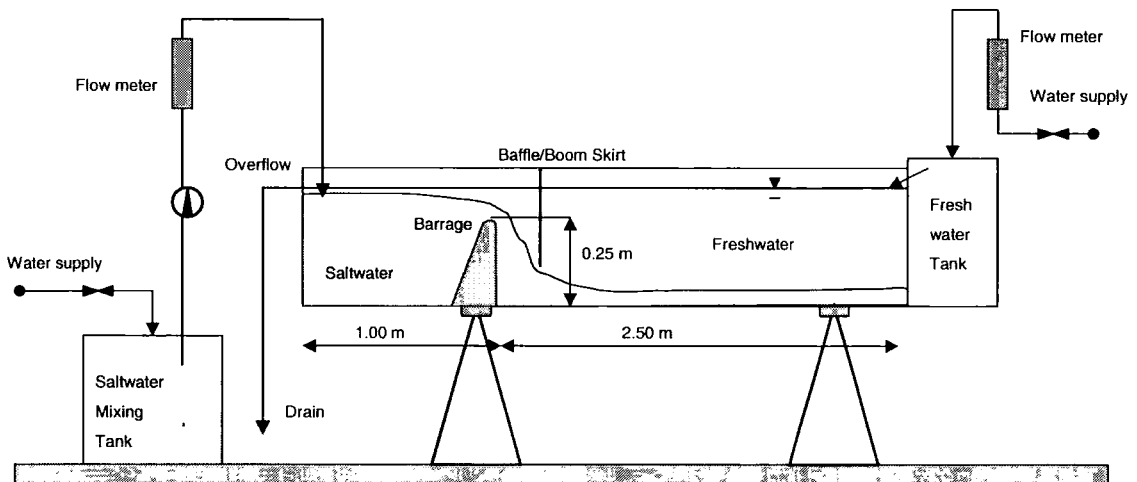
Figure 3-9 Schematic of the barrage flume tank

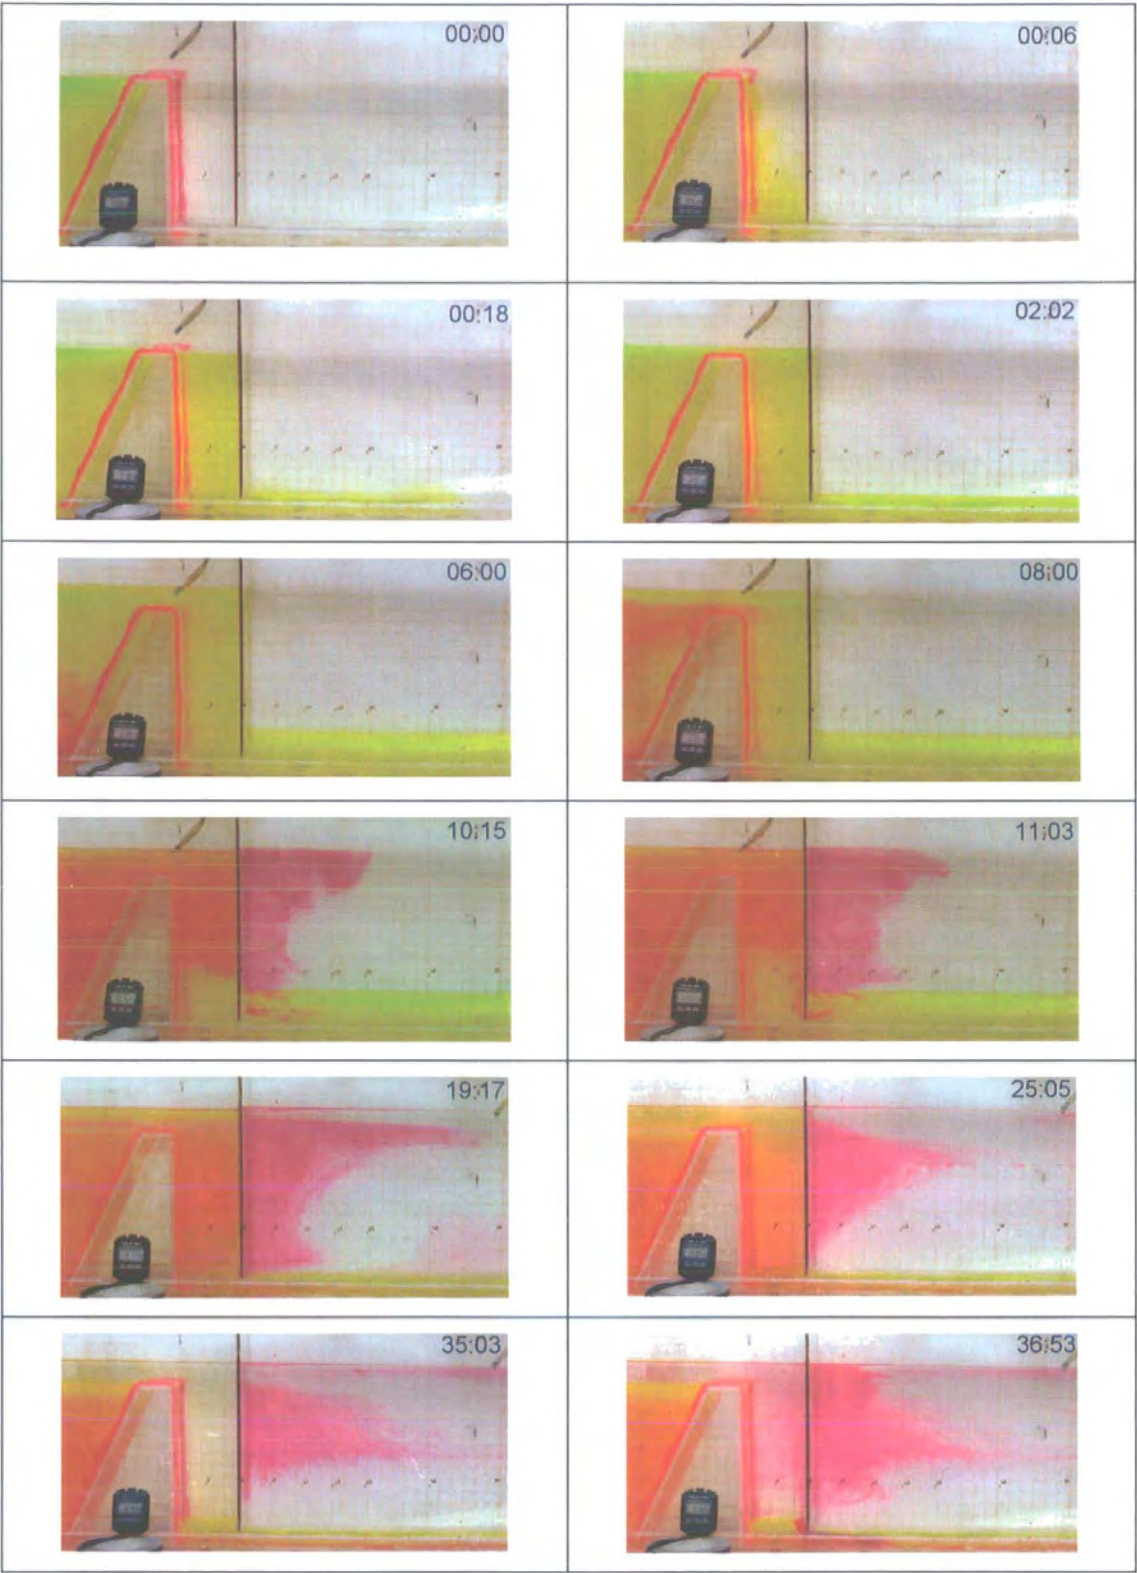
**Figure 3-10 Flume experiment No. 1: Baffle, yellow dye indicates salt-water, red dye is injected to visualize hydrodynamic patterns within layers and at interfaces, first injection point is downstream of barrage in the lower layer (06:00 min.), second injection point is upstream of the baffle throughout the water column (10:15 min.)**

As indicated in Figure 3-10 (00:18) the saltwater overtopped the barrage in a turbulent jet and plunged into the mixing zone of turbulent eddies downstream of the baffle. After an

The visual observations of the first experiment involving a baffle fitted upstream of the barrage are shown in a selection of photographs in Figure 3-10. The elapsed time of the experiment is given in minutes and seconds for each observation.

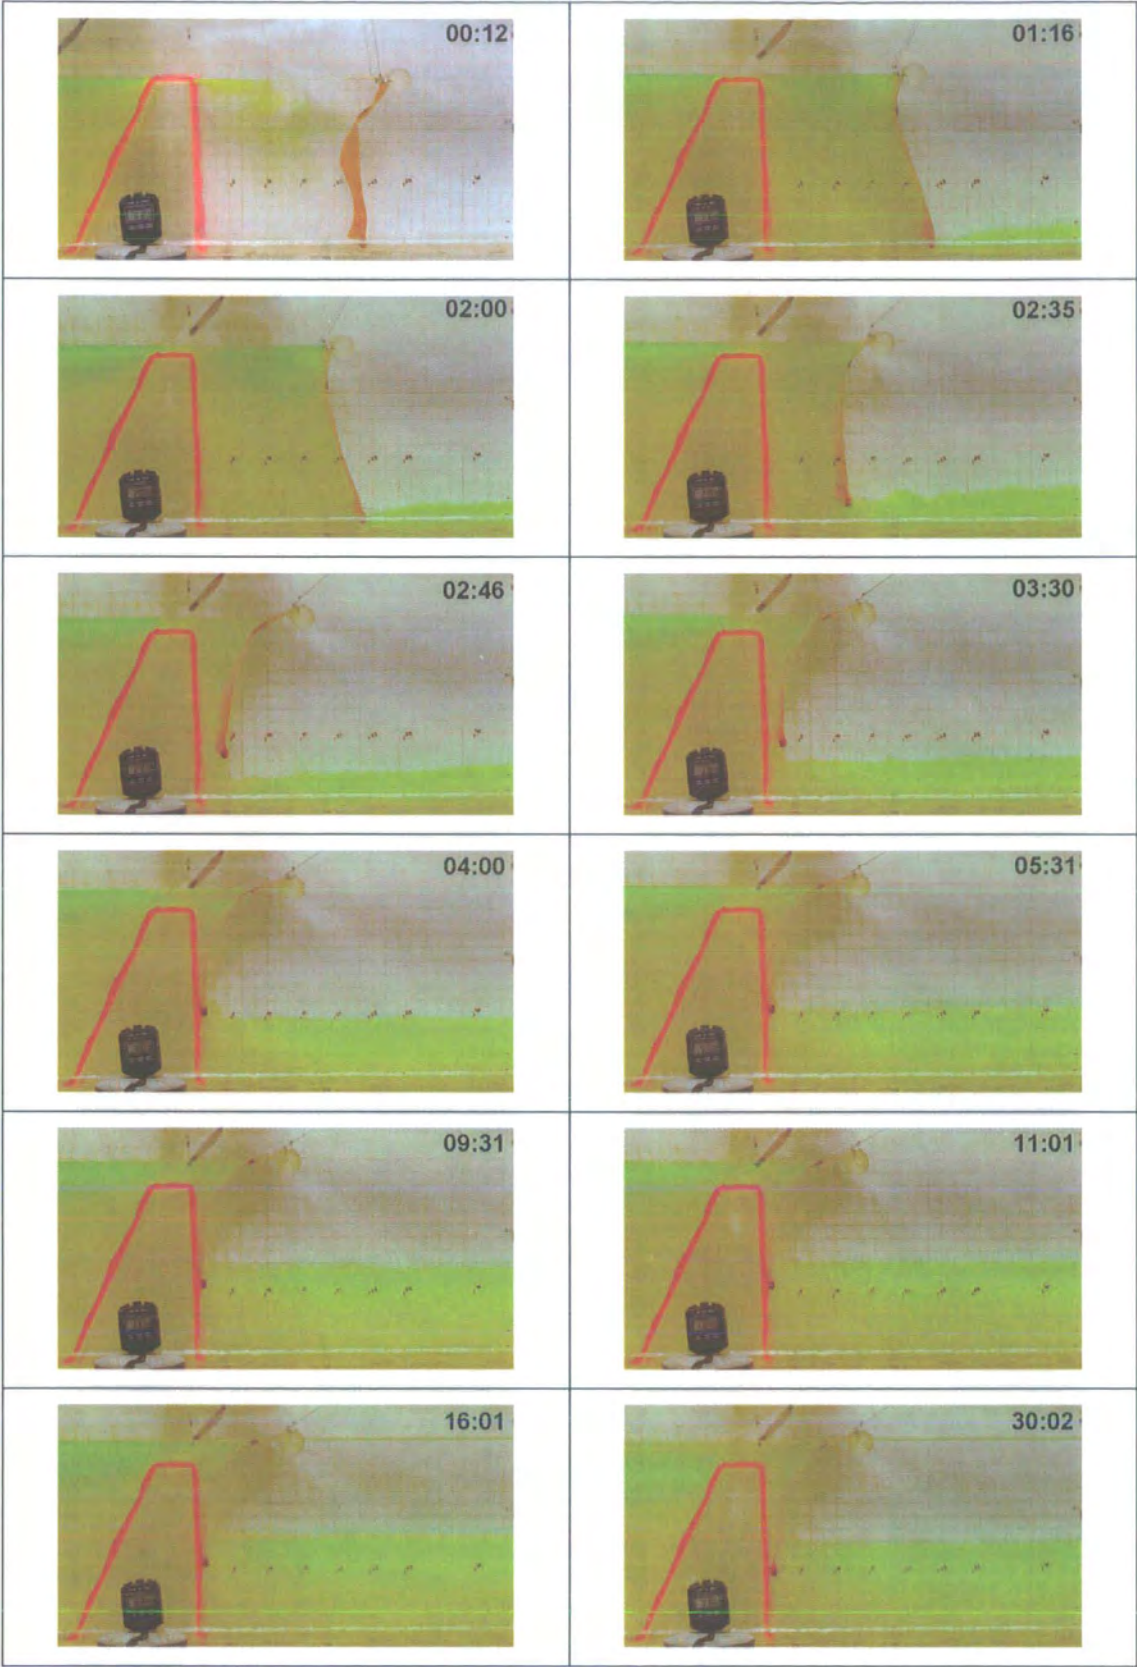
Figure 3-11 Flume experiment No. 2: Boom/Skirt at  $l=25$  cm, 21 g weight, yellow dye indicates salt-water

In experiment number 2, the fixed baffle was replaced by the flexible boom/skirt assembly and the results are shown in Figure 3-11.

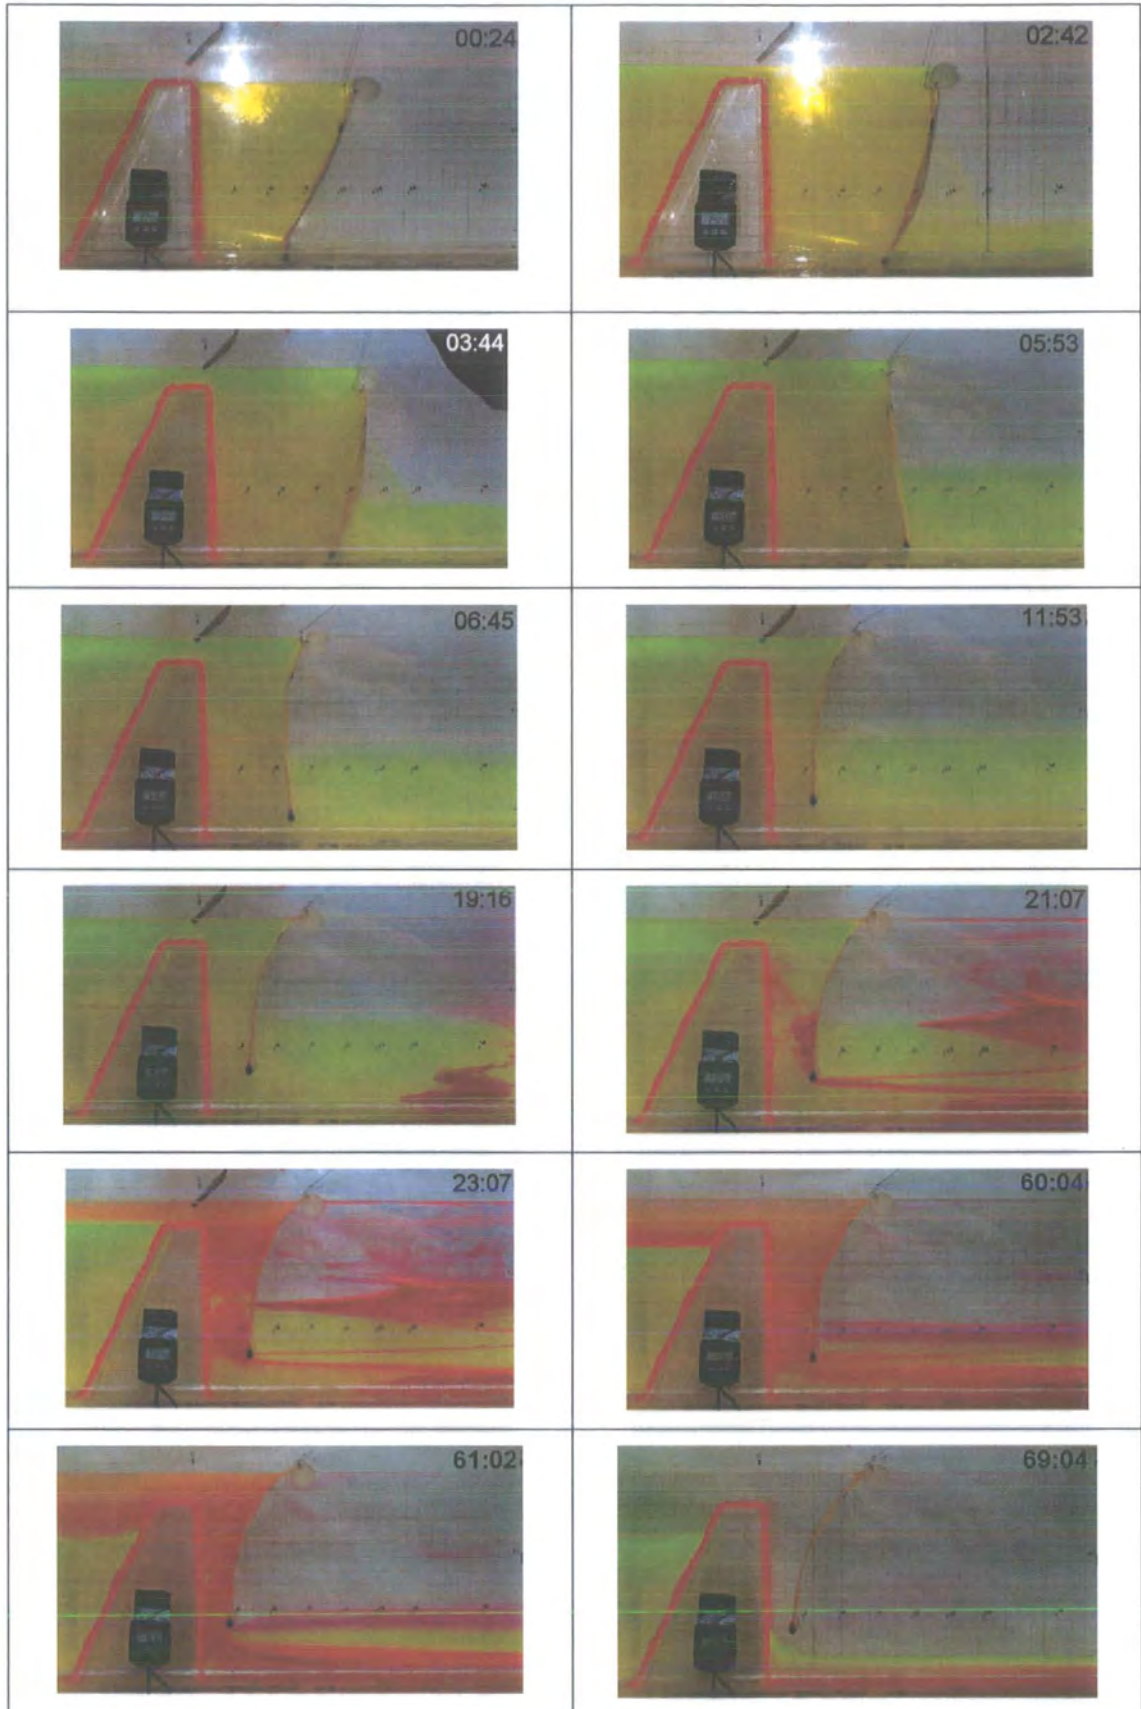
**Figure 3-12** Flume experiment No. 3: Boom/Skirt at  $l=25$  cm, 27 g weight, yellow dye indicates salt-water, red dye is injected to visualize hydrodynamic patterns within layers and at interfaces, first injection point is upstream into the lower salt-layer (19:16 min.), second injection point is upstream around FSI (21:07 min.)

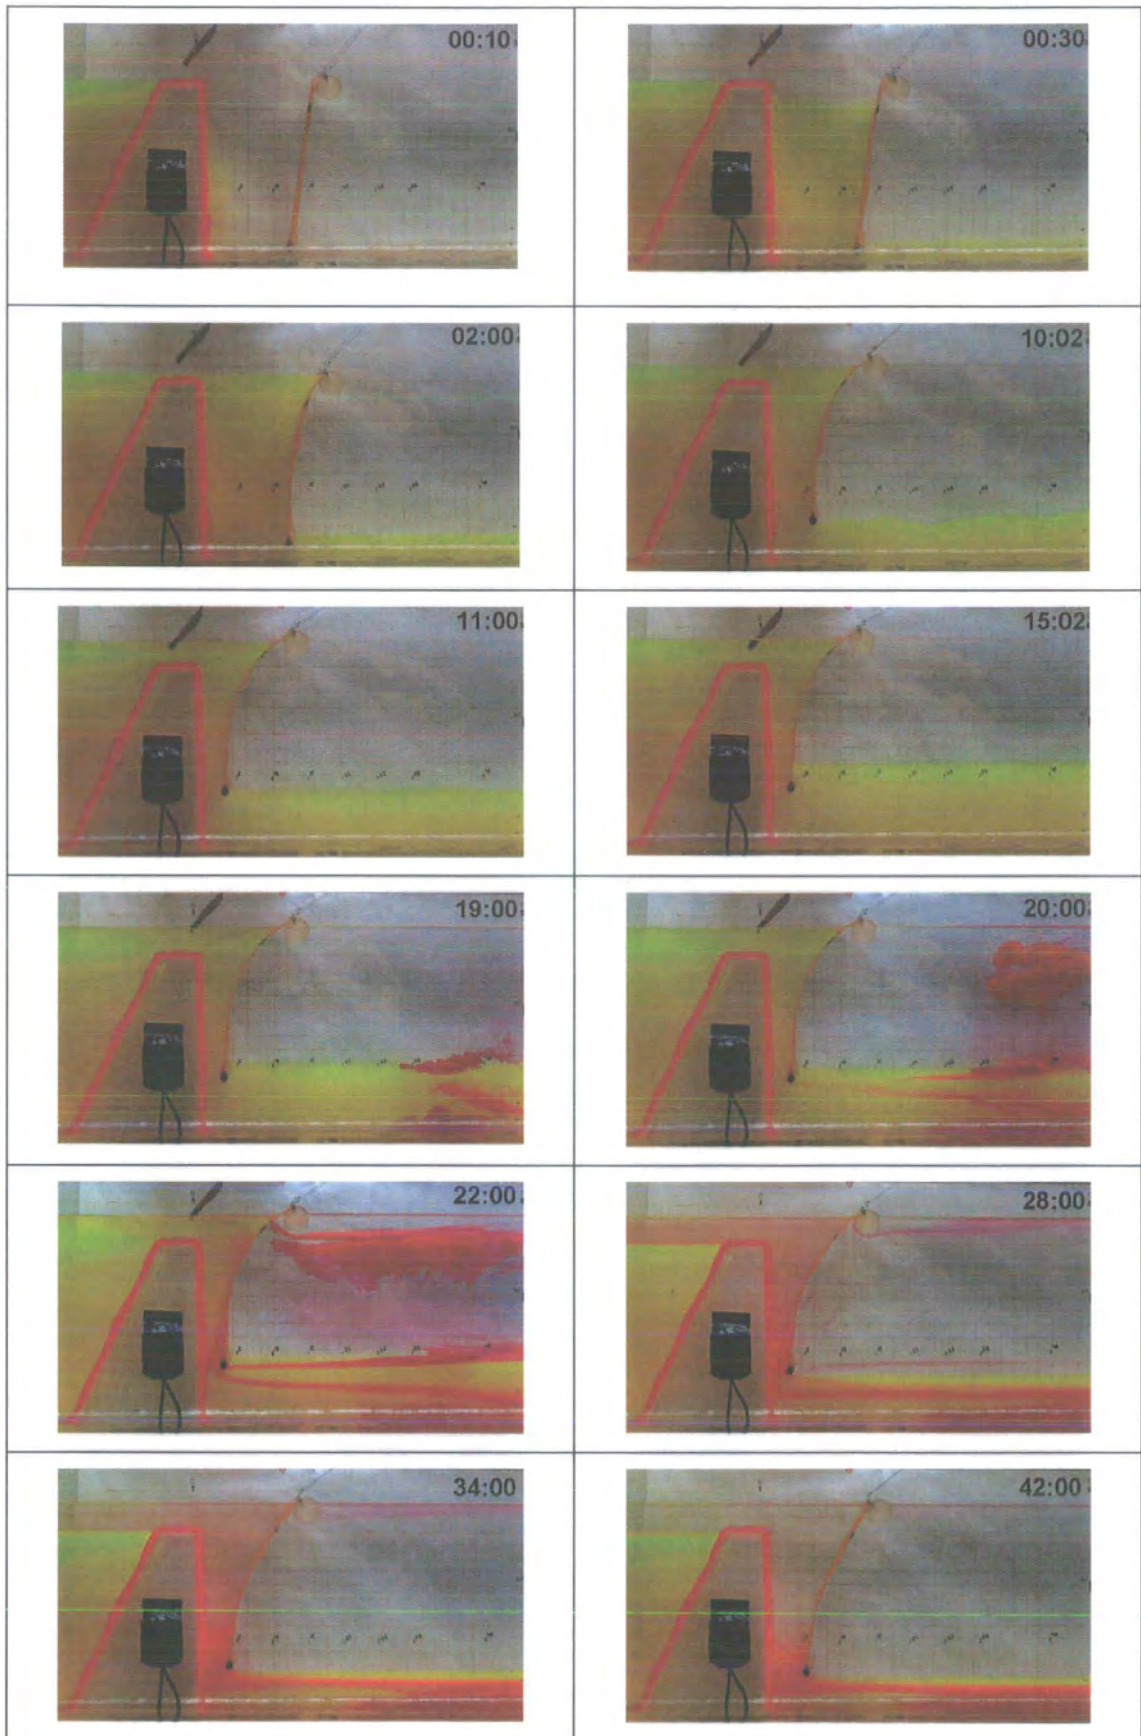
**Figure 3-13** Flume experiment No. 4: Boom/Skirt at  $l=23$  cm, 27 g weight, yellow dye indicates salt-water, red dye is injected to visualize hydrodynamic patterns within layers and at interfaces, first injection points are upstream into the lower salt-layer and at the FSI (19:00 min.), second injection point is upstream into the freshwater layer (20:00 min.)

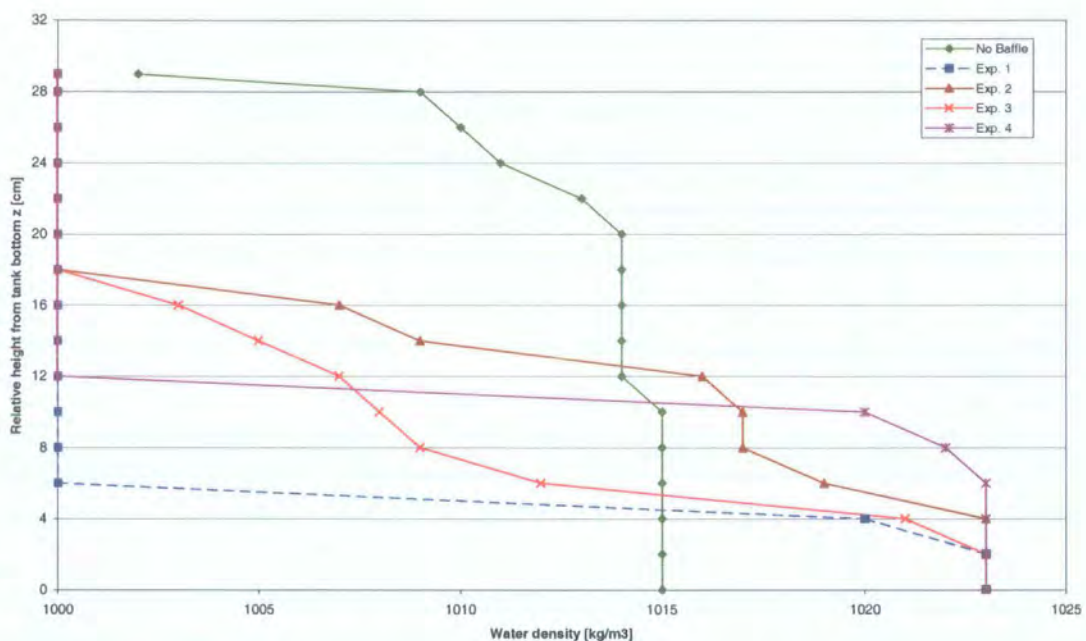
minutes of all the experiments, which was gradually strengthened by the continuous saline influx. Since the baffle opening dictated the velocity and nature of the propagating jet, the interface properties of experiment 2 and 3 were different to experiment 1 and 4. The initial underflow restriction in experiment 3 of  $a=0$  cm created a turbulent salt plume from which a thick interlayer evolved. In experiment 2, the initial baffle opening of  $a=1.3$  cm might have been sustainable, but the following widening due to the lift of the curtain displaced a large amount of saltwater upstream, causing substantial mixing. Subsequently, the interfacial gradient at  $t=15$  min. was less pronounced for experiment 2 and 3 as documented by the density profiles for the upstream position  $l=0.25$  m shown in Figure 3-14.

Figure 3-14 Density profiles for flume experiments at  $t=15$  min., 25 cm u/s of the barrage

However, when compared to the saline influx studies conducted by Whyte (2003) without a baffle/skirt installed, all baffled systems provided less upstream accumulation of saline waters. The vertical density gradient of the same experiment without the baffle (Figure 3-14) indicated a high degree of mixing between the competing water bodies after 15 min. By contrast, the baffled systems, in particular those in experiment 1 and 4, developed a pronounced interface with a sharp salinity gradient at  $z=6$  cm and  $z=12$  cm respectively. As a result of the sharp gradient, these systems offered an increased stability of the interface which buffered against shear forces from movement within the layers (Abraham et al., 1979; Shuy et al., 1998). The layer velocities ( $U$ ) in the three-layered water column in experiment 3 were calculated from the rhodamine dye movement (Table 3-1).

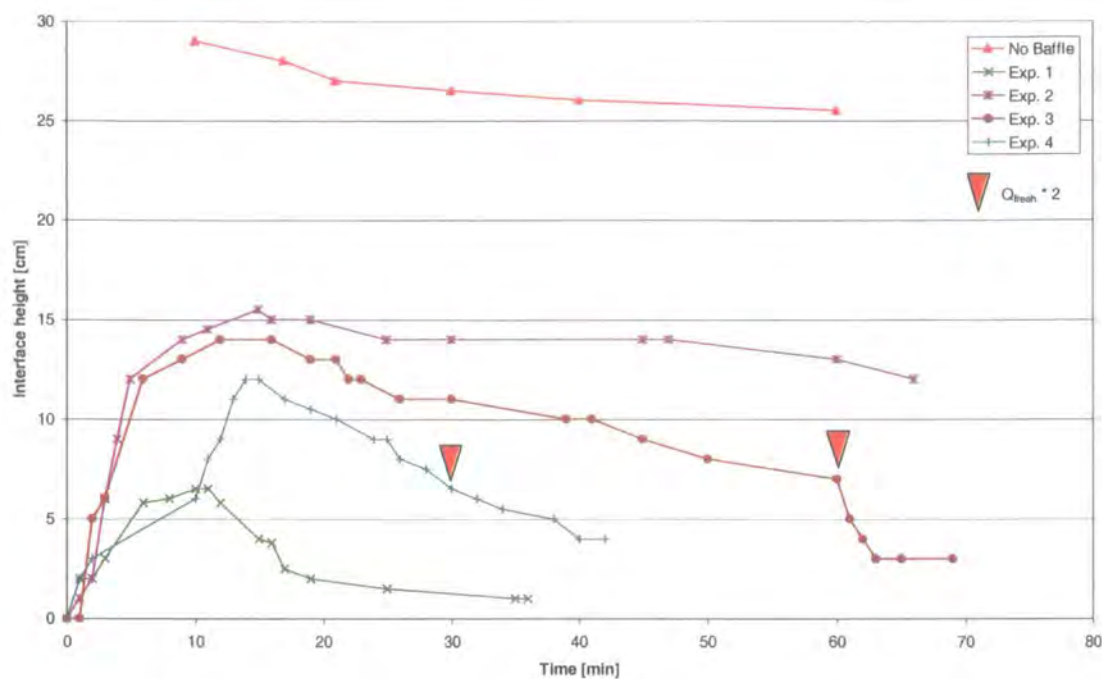
Figure 3-15 FSI height during flume tank experiments

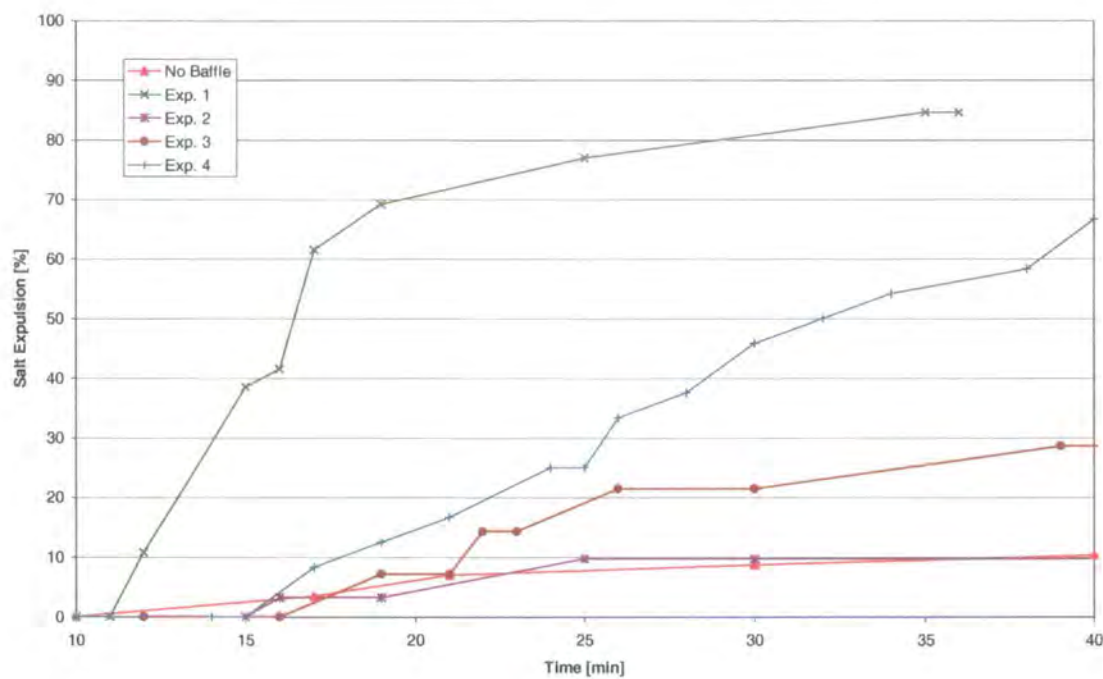
Figure 3-16 Expulsion rates in % for flume tank experiments

The flux rates (Figure 3-15) of the baffled impoundments, show a decrease over time, while most of the saline displacement is attained within the first 30 min. after the freshwater flow has been started. When compared to the ‘unbaffled’ system, expulsion rates of up to 75 % (Figure 3-16) higher were achieved with the baffles during the first 30 min. of freshwater flow. Nevertheless, during none of the experiments a complete removal of the saline layer

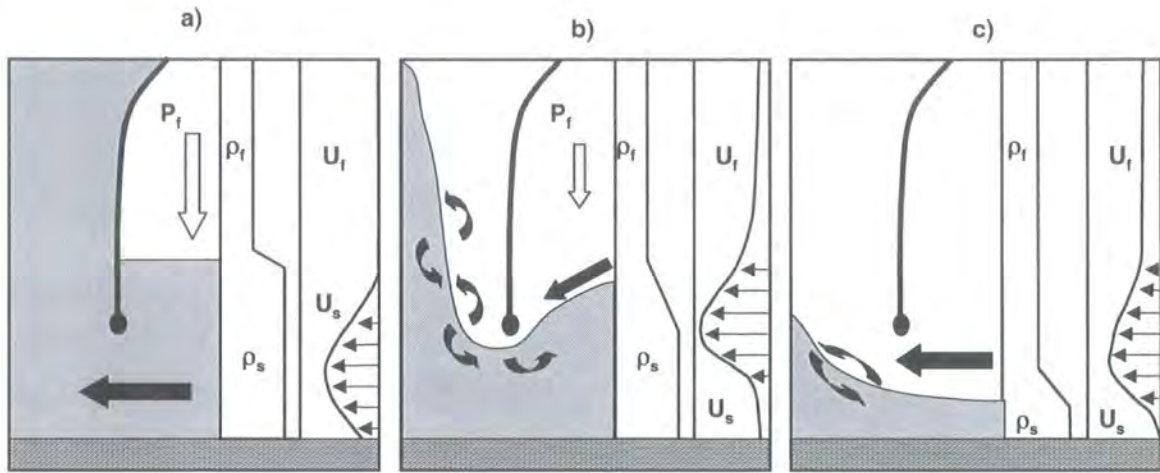
Figure 3-17 Interface at the baffle opening

The schematic in Figure 3-17 points out the main observed patterns regarding interface height and expulsion mechanism. If the interface drops below the baffle height, freshwater escapes the system due to the balancing of hydrostatic loads. The velocity shear at the interface is enhanced in the vicinity of the underflow opening and causes higher entrainment rates locally (Figure 3-17-b)). Furthermore, the loss of freshwater is accompanied by a reduction in the hydrostatic load ( $P_f$ ) on the salt layer upstream. Eventually, the dominant expulsion mechanism changes from hydrostatic displacement to hydrodynamic entrainment (Figure 3-17-c)). As stated in section 3.3.4, the rate of entrainment depends on the dominant mixing mechanism at the interface which is defined by the Richardson number. The Richardson numbers for an experimental set-up similar to that in Experiment 1 were calculated by Whyte (2003) using an ultrasonic velocity profile monitor at a position 25 cm upstream of the barrage. The values ranged from 12 to 54 indicating stability with no turbulent mixing processes across the interface. The observations in experiment 1 and 4 comply with these findings, since turbulence was absent during the entrainment phase which is well documented by the laminar dye movement along the interface in Figure 3-10 (after 36:53 min.) and Figure 3-13 (after 26:00 min.). Therefore, entrainment was possibly induced by small scale mixing processes such as Holmboe waves (section 3.3.4) as a result of velocity shear from the moving freshwater layer. It is shown in Figure 3-15, that the rate of expulsion due to entrainment is very small compared to expulsion via positive displacement. In addition, entrainment involves the loss

was achieved within the given time. This is a result of the declining interface which eventually reaches the height of the baffle opening and thereby changes the expulsion mechanism from hydrostatic to hydrodynamic (Figure 3-17).

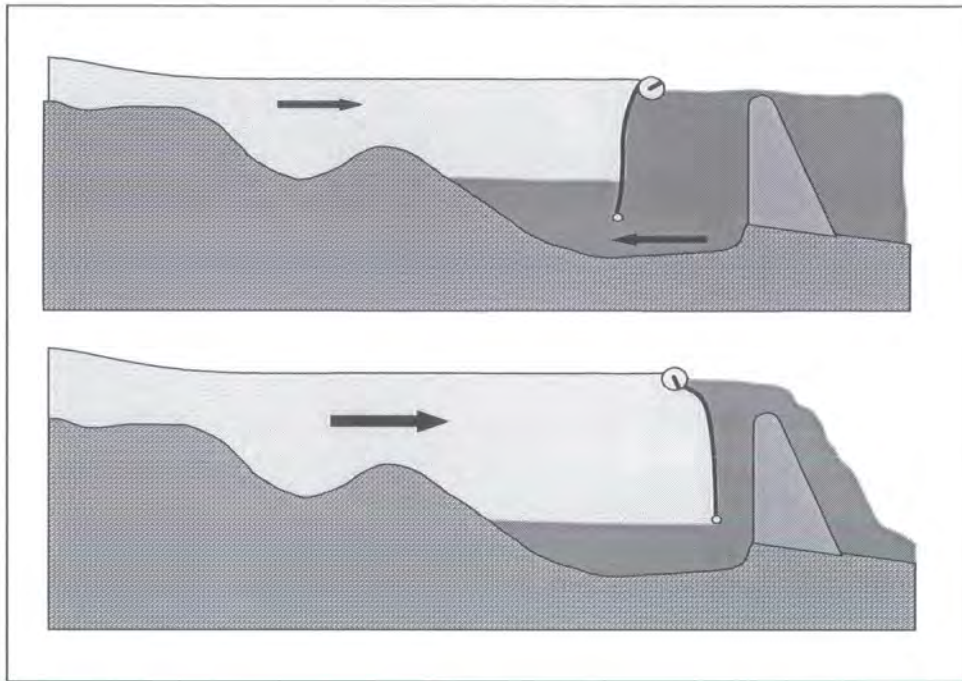
**Figure 3-18 Boom/Skirt system under different hydrostatic and hydrodynamic conditions**

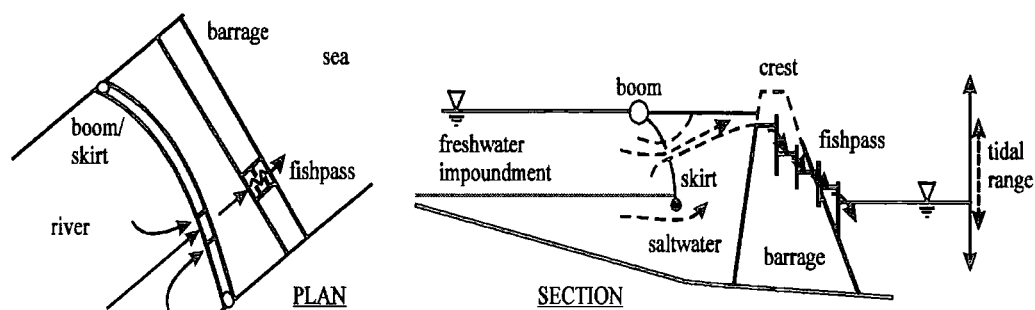
**Figure 3-19 Boom/Skirt system with orifices (from Burrows and Ali, 2001)**

One of the main experimental disadvantages of the boom/skirt design, as compared to the fixed baffle, was the development of side flows between the curtain and flume wall which significantly reduced hydrostatic loads upstream. Considering the prototype channel span of 105 m (Chapter 2), these side flows would be considerably smaller in reality, resulting in an increased efficiency of the system during seawater expulsion. This, however, also creates a considerable load on the construction anchorage and on the flexible curtains in particular. One option to reduce these loads, and also to remove a major criticism of the boom/skirt concept, is the introduction of orifices (Figure 3-19) into the curtains. Preferably located

near the fish-pass, they would enable the free movement of fish, whilst ensuring a reduction of freshwater loads at the same time.

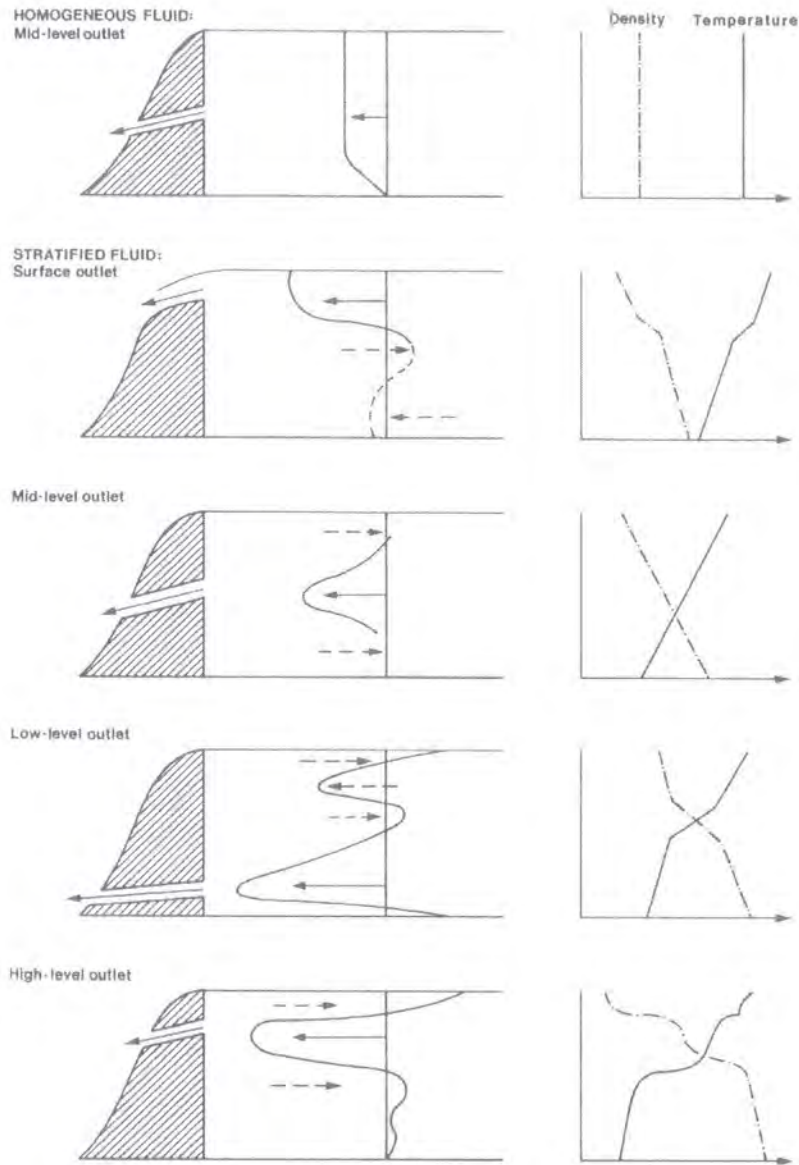
For summer conditions, the height of extraction could therefore either result in DO supersaturated, nutrient depleted, warm water or oxygen depleted, nutrient rich, cold water. However, these assumptions are based on observations made in freshwater reservoirs with density stratification occurring as a result of thermal stratification. Within estuarine impoundments, density stratification develops as a result of the interaction between fresh and salt water which creates a considerably larger vertical density gradient in the water column. Although estuarine barrage designers included the water release option for years (Wansbeck Barrage, completed 1975), surprisingly limited information is available on its impact in highly stratified impoundments.

Figure 4-1 Effects of selective withdrawal from various depths of impoundments (Petts, 1984)

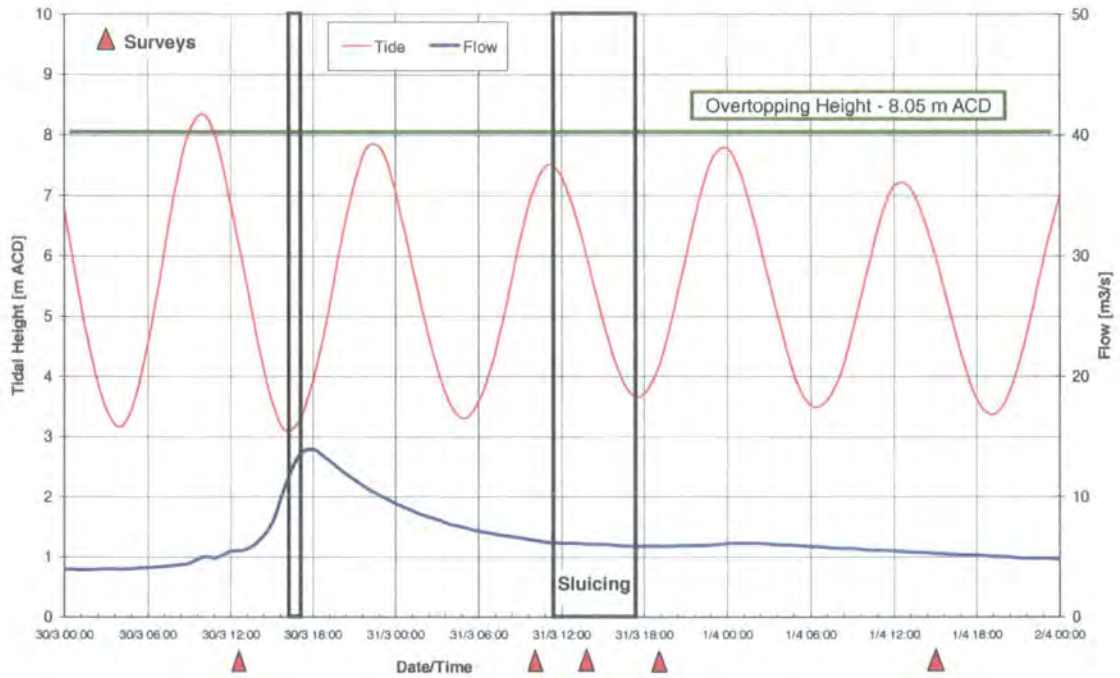
02/04/93, targeting neap tide conditions with low freshwater inputs (Figure 4-2) while SCC engineers operated one of the shipping lock penstocks. Incorporated in the barrage design are a total of two upstream culverts of 2 m<sup>2</sup> opening, which allow abstraction of water from the barrage base to level the lock. During the main survey of 31/03/93 SCC engineers operated one penstock at maximum allowed discharge (30 % open as defined in Technical Specification by W.S Atkins) between high water and low water (Figure 4-2) while intensive surveying was carried out in the impoundment on a 1.5 hour rolling programme.

Figure 4-2 Environmental variables during sluicing survey on the Tawe in 1993

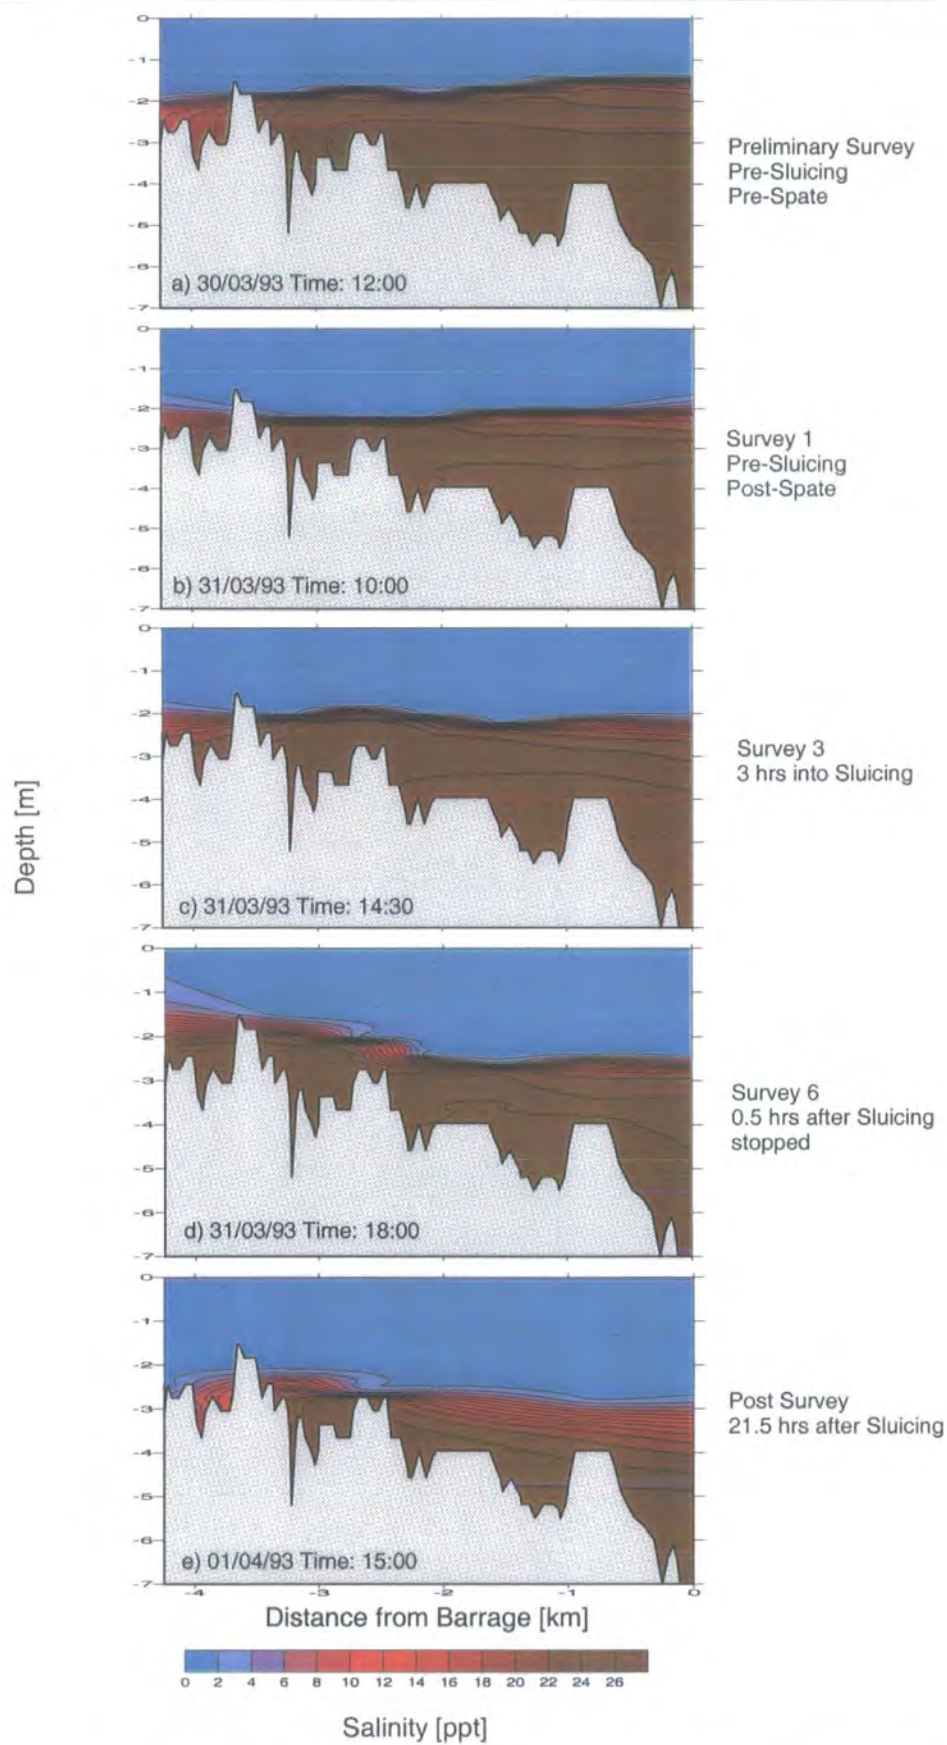
The monitored salinity records from the surveys (Figure 4-2) are displayed as contour plots in Figure 4-3. The preliminary survey on the 30/03/93 (Figure 4-3 a)) indicated that the impoundment was stratified with a pronounced halocline at 1.5 to 1.8 m depth. However, the flow spate of 14 m<sup>3</sup>/s and a 50 min. penstock operation on the evening prior to the main survey (Figure 4-2) resulted in a slight lowering of the halocline, as indicated in the initial profile taken prior to the sluicing operation on the 31/03 (Figure 4-3 b)).

Figure 4-3 Salinity profiles for the sluicing survey on the River Tawe 1993

During the 6 hour penstock operation on the 31/03 the halocline dropped from an initial depth of around 2.0 m to a depth of 2.5 m within the lower impoundment up to a distance of 2.7 km from the barrage (Figure 4-3 d)). Initially, the upper impoundment remained relatively stagnant possibly due to the bed elevation at Whiterock Bridge (2.7 km upstream) and the distance from the barrage which prevented levelling of the halocline. The survey on the 02/04 demonstrated that the upstream level of the halocline was affected with a delay, bringing the halocline depth to around 3.0 m for the whole impoundment. For the shallow upstream site this resulted in a return to freshwater conditions while for other sites the falling halocline lead to trapped saltwater pools in the deep pockets.

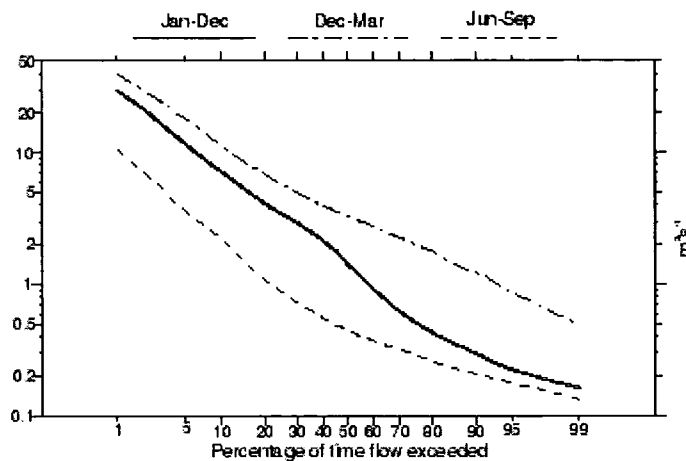
On its way, the river passes mainly through pasture and woodland before reaching the population centres at Morpeth, Stakeford/Guide Post and Ashington. It is also in these lower reaches where the main tributary, the River Font, joins the River Wansbeck and where the only EA Gauging Station at Mitford (NZ 175 858) is located. The station accounts for 84.6 % of the catchment and the average daily flow is given as  $3.24 \text{ m}^3/\text{s}$  since recording started in 1968 (National Flow Archive, 2003). The 95 % and 10 % exceedance flows for the River Wansbeck are  $0.217 \text{ m}^3/\text{s}$  (Q95) and  $7.092 \text{ m}^3/\text{s}$  (Q10) respectively (Figure 4-5).

**Figure 4-5 Flow duration curve for daily gauged flows on the River Wansbeck since 1968 (National Flow Archive, 2003)**

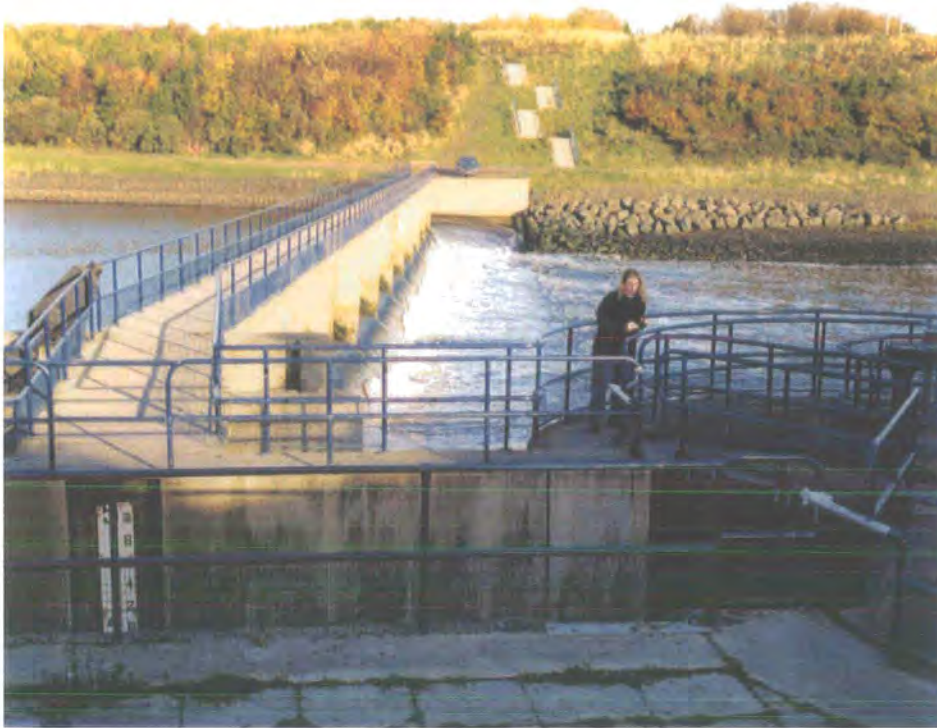
their work in May 1975 at a cost of £ 273,000, while the Riverside Park scheme, including bank gabion works, was finished in 1977 at a cost of £ 382,000. The height of the weir crest is fixed at 4.74 m ACD (2.14 m AOD), which was chosen primarily to provide sufficient depth for boats entering the impoundment upstream (1.6 m draught) and, secondly, to allow overtopping of the barrage in order to *“assist in maintaining water quality in the summer months .....by creating a limited but regular turn round of water stored in the lake”* (Curtis and Dawson, 1978).

**Figure 4-6 View of the Wansbeck barrage from the south-bank**
